Belzona helps to repair VRM crusher bearing housing

ID: 9632

Industry: Cement
Application: ENC-Engines and Casings
Substrate: Cast Iron
Products: Belzona 1121 (Super XL-Metal), Belzona 9411 (Release Agent)

Customer Location: Al Hfouf Plant
Application Date: January 2023

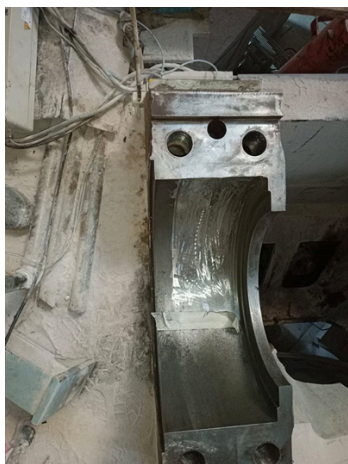
Excessive vibrations in the VRM crusher led to damage in the bearing housing, resulting in wear between the housing and the bearing. This wear ultimately caused bearing failure, leading to the shutdown of the crusher.

Bottom side of the bearing housing before the repair of Belzona

Using Belzona release agent and Belzona 1121, the old bearing was utilized as a former to restore the damaged/worn area to its original profile. Surface preparation was carried out using power tools to achieve the minimum profile recommended by Belzona

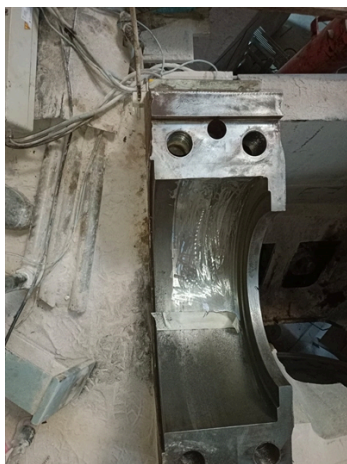
Bearing housing suffered wear and metal loss

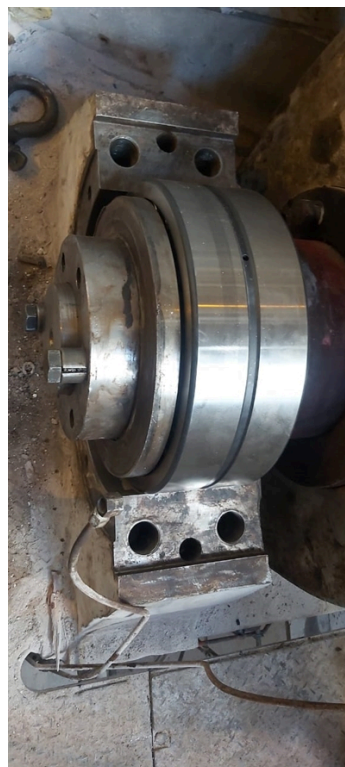
VRM crusher bearing housing in operation

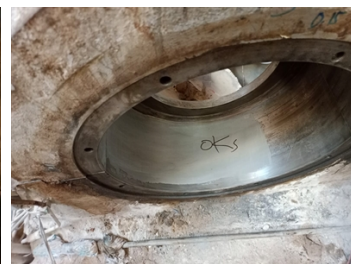
Belzona 1121 (Super XL-Metal) repairs the crusher bearing housing
