Feed Rotor for CHP plant protected

ID: 9633

Industry: Power

Application: PDP-Positive Displacement Pumps

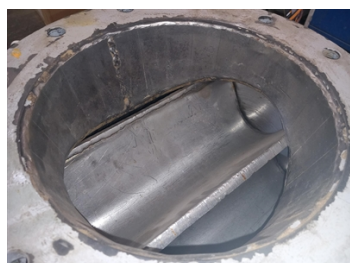
The rotor whilst still in it's original housing

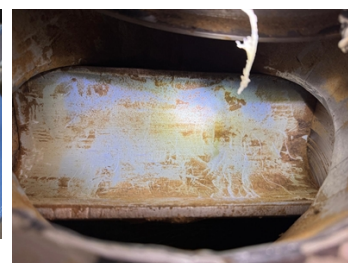
1 year on and the coating is still perfect, doing exactly as intended by avoiding build up of material and allowing the rotor to perform at full efficiency, whilst protecting against erosion

12 months on and the coating to the rotor is still in perfect condition, allowing for performance from the rotor with NO unexpected downtime or Reactive maintenance required.
