# Balconies and stairwells Improvements

ID: 9635

Application: FPA-Floor Problem Areas

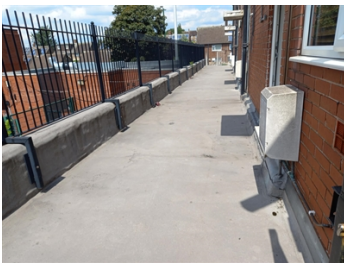
Multiple issues needed to be addressed in this large project where 2 groups of 5 flats had issues with spalling concrete to stairwells, unsafe, broken and slippery concrete stairs, spalling concrete in the stairwells and leaking bitumen on the balconies above. The stairwell brickwork also required sealing

Bitumen Balconies letting in water to structures below

Access was enabled to the flats using boards and a system where half the balconies were coated with the Belzona 3131 at a time, including the total blinding of Belzona 9231 Surefoot aggregate

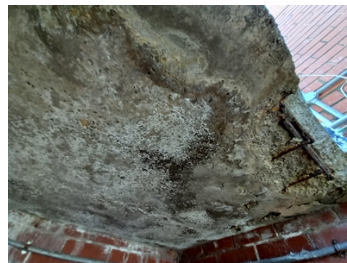
Stairwells showing severe spalling with possibility of falling concrete

All the spalling areas were hammer tested, cleaned and repaired using Belzona 4141 and Belzona 4131

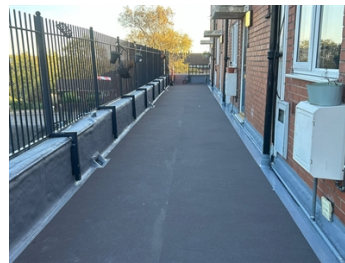
Balconies fully coated with the addition of Belzona Surefoot aggregate
