Leaking water line repaired with Belzona 1161 and 1212

ID: 9637

Application: VPF-Valves, Pipes and Fittings

Products: Belzona 1161 (Super UW-Metal), Belzona 1212

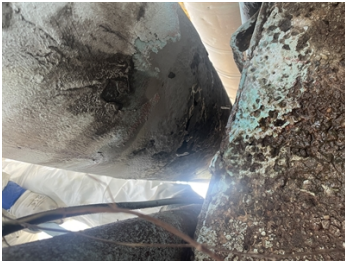
Customer had a significant leak on a 12" supply water line. The water line was corroded at the pipe support base, with multiple hole through locations.

Corroded pipeline.

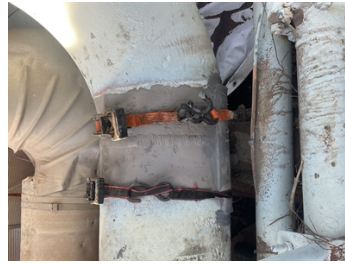
Application of cold bonded plate with Belzona 1161.

Customer Called late afternoon on a Friday with this pipe leak, Belzona was able to mobilize and be on site within an hour. the application crew was able to plate bond over the multiple holes in pipe and then we wrap over the plate to secure plate and stop any future leaks. Customer was able to fill line back up in a matter of a few hours saving them days of down time and also saving money

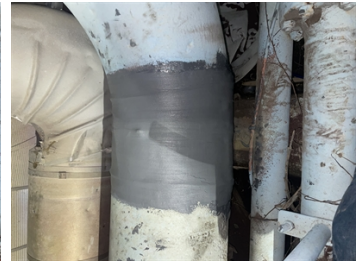
Finished application with Belzona 1212.

Cold plate bond using Belzona 1212, then wrapping with Belzona 9341 Reinforcement Sheet with Belzona 1161
