Belzona provides Internal pump refurbishment with ceramic coating system

ID: 9639

Application: CEP-Centrifugal Pumps

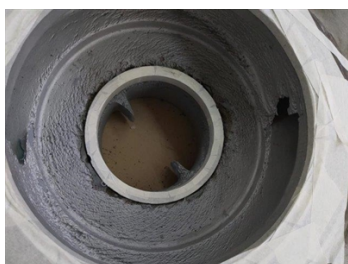
The pump suffered severe erosion caused by high solid content in the fluid

Erosion evidence on pump component due to high solid content

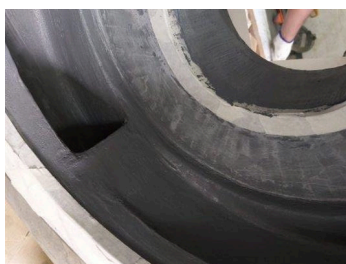
Surface preparation on the pump before the application of Belzona system

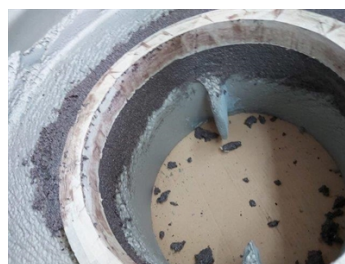
Pump surface was rebuilt with Belzona 1311 (Ceramic R-Metal)

1. Apply Belzona 1311 to rebuild the worn-out metal
2. Overcoat the rebuilt pump with Belzona 1321 (Ceramic S-Metal)

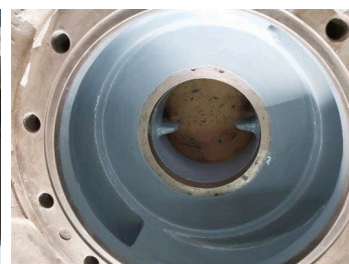
Once the surface was rebuilt, Belzona 1321 (Ceramic S-Metal) was applied to enhance protection and prevent further damage.
