# Belzona provides Internal pump refurbishment with ceramic coating system

Application: CEP-Centrifugal Pumps

Products: Belzona 1311 (Ceramic R-Metal), Belzona 1321 (Ceramic S-Metal)

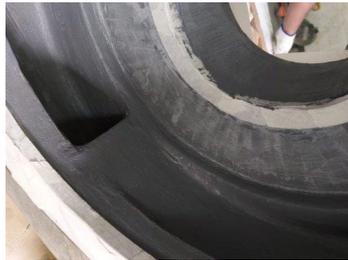
The pump suffered severe erosion caused by high solid content in the fluid

Erosion evidence on pump component due to high solid content

Surface preparation on the pump before the application of Belzona system

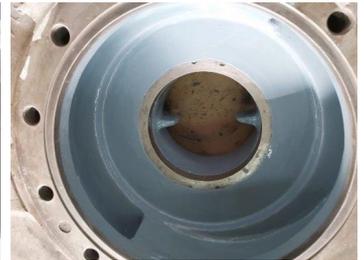
Pump surface was rebuilt with Belzona 1311 (Ceramic R-Metal)

Once the surface was rebuilt, Belzona 1321 (Ceramic S-Metal) was applied to enhance protection and prevent further damage.
