Pipe Girth Weld Internal Coating

ID: 9640

Industry: Oil & Gas
Application: VPF-Valves, Pipes and Fittings
Substrate: Carbon steel
Products: Belzona 1391T

Customer Location: Saudi Arabia
Application Date: June 2021

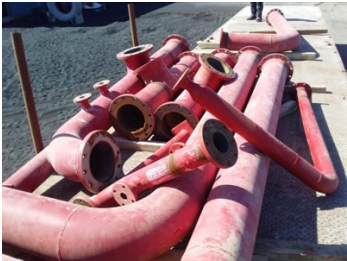
Pipes are coated with Fusion Bonded Epoxy Coating (FBE) from manufacture but after welding, the fitting FBE coating got burned and needed repair.

Damaged pipe girth

1. Do grit blasting to remove the burned coating until the required profile and cleanliness is achieved.
2. Apply Belzona 1391T onto the internal fitting.
3. Spark testing to detect if there are any pinholes.

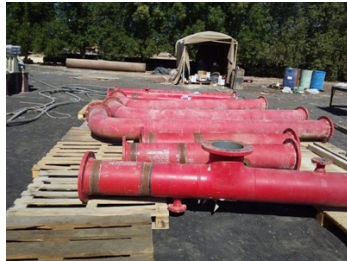
Damaged pipe girth needed repair

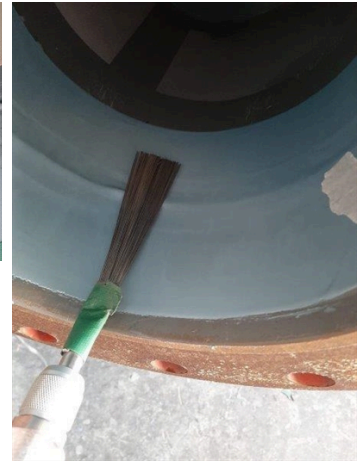
Spark testing in progress to detect pinholes for a flawless protective coating.
