Pump Housing Repair and Coat

ID: 9641

Industry: *Water / Wastewater*
Application: *PDP-Positive Displacement Pumps*

Substrate: *Cast Iron*
Products: *Belzona 1311 (Ceramic R-Metal), Belzona 1321 (Ceramic S-Metal)*

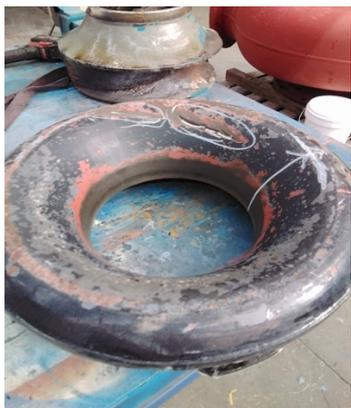
Customer had issues with pump housing getting severely eroded in service.

Damaged pump housing.

Due to the damage of the pump housing, repair was required urgently with a lead time on a new pump been quite long. A Belzona repaired offered a fair quicker long term repair solution with a 1-2 week lead time.

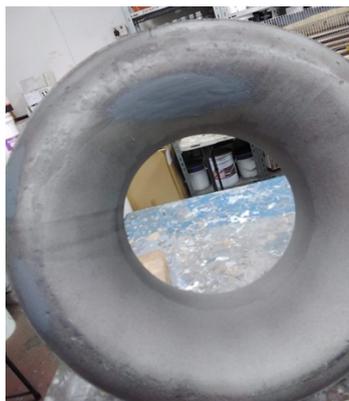
Pump housing abrasive blasted and Belzona paste grade metal utilised to repair erosion.

Pump housing was abrasive blasted to a S.A 2.5 standard (75 micron) profile before all eroded sections been rebuilt with Belzona 1311 paste grade metal. There after 2 coats of Belzona 1321 was applied for long term protection against erosion.

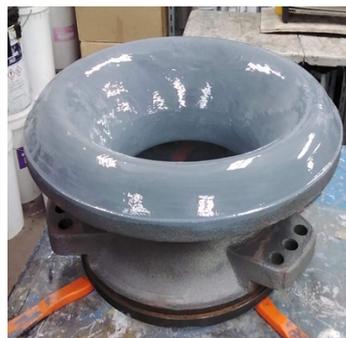
First coat of Belzona 1321 applied.

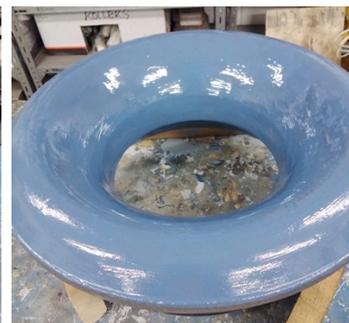
Pump housing complete with final coat of Belzona 1321.
