Belzona improves efficiency of cooling water circulation system centrifugal pump

ID: 9646

Application: CEP-Centrifugal Pumps

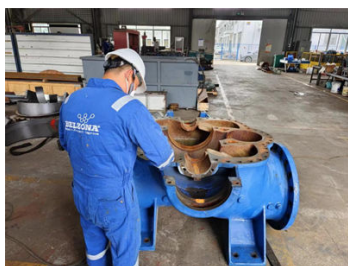
Degreasing and chamfering pump casing surface

The application was carried out in accordance with Belzona System Leaflet CEP-10. First, all sharp edges were grounded to give a radius of not less than 3 mm and the matching surfaces were protected. Then, grit blasting was performed. After cleaning, Belzona 1111 was used to repair and fill pits. Belzona 1341 coating was used for protection and efficiency improvement. After completion, the impeller was dynamically balanced.

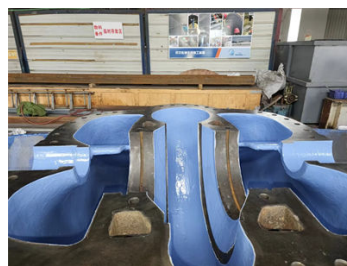
2 coatings of Belzona 1341 completed

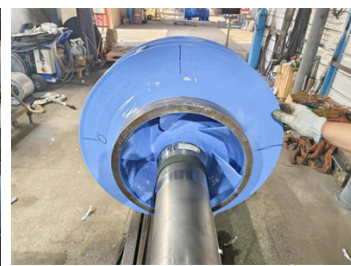
Dynamic balancing test after the impeller is coated with Belzona 1341
