Cold Bonding Pipe Support Brackets to Tank

ID: 9648

Industry: Oil & Gas
Application: TCC-Tanks and Chemical Containment Areas
Substrate: Stainless-steel
Products: Belzona 7311

Customer Location: Geismar, Louisiana
Application Date: August 2024

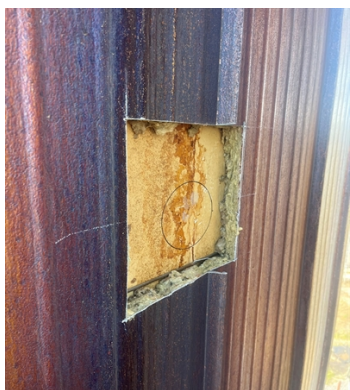
Client identified and marked where support to be bonded on tank exterior.

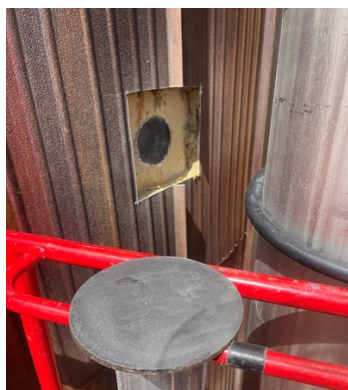
Pipe support and bond area perspiration.

Application was carried out with all surface preparation executed with TFT Pneumatic Rough Boy sparkless profiling tool. Therefore, eliminating any hot work in areas and potential damage to internal liner of vessel.

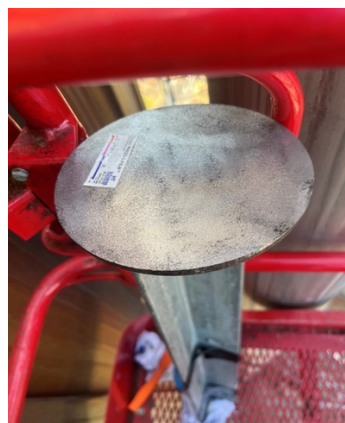
Pipe support bond pad surface profile readings were taken prior to bonding.

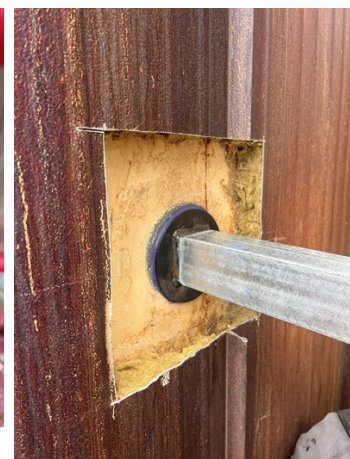
Pipe support bonded to prepared tank substrate Belzona 7311.

Belzona 7311 was chosen as an alternative to welding. Belzona 7311 repair also offered the ability to cold bond the pipe support without the need for open flame hot work and possible damage internal liner of vessel.
