# BELZONA 1814 SCREW CONVEYOR PROTECTION

ID: 9652

Industry: *Water / Wastewater*  
Application: *SHM-Solids Handling Machinery*

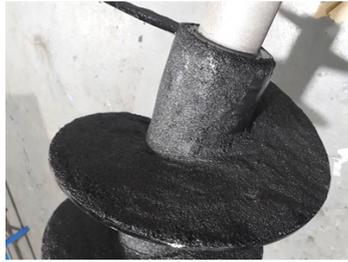
Initial condition

*Screw conveyor used to skim sludge from the base of a silo at a biomass plant.*

High abrasion was leading to unprotected screws only lasting 3-4 months in service. Previous Belzona applications on this type of screw was completed with Belzona 1812, which extended their life to over 2 years.

The screw conveyor was grit blasted to SA2 1/2 with a minimum surface profile of 3 mil (75 microns). The area to be coated was then cleaned and degreased using Belzona 9111. Belzona 1814 was applied to the entire area of the conveyor to provide long-term protection against heavy abrasion.
