BELZONA 1814 SCREW CONVEYOR PROTECTION

ID: 9652

Industry: *Water / Wastewater*
Application: *SHM-Solids Handling Machinery*

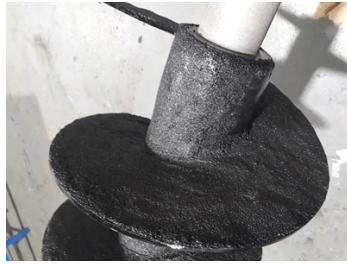
Initial condition

High abrasion was leading to unprotected screws only lasting 3-4 months in service. Previous Belzona applications on this type of screw was completed with Belzona 1812, which extended their life to over 2 years.

The screw conveyor was grit blasted to SA2 1/2 with a minimum surface profile of 3 mil (75 microns). The area to be coated was then cleaned and degreased using Belzona 9111. Belzona 1814 was applied to the entire area of the conveyor to provide long-term protection against heavy abrasion.

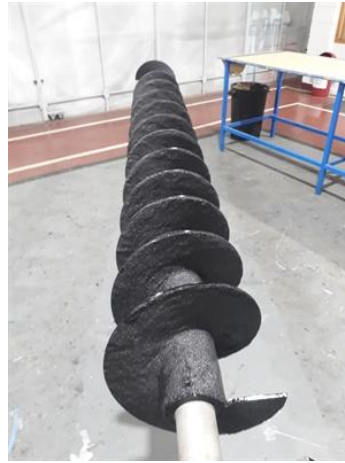
After Belzona 1814
