BELZONA 1814 SCREW CONVEYOR PROTECTION

ID: 9652

Industry: Water / Wastewater
Application: SHM-Solids Handling Machinery

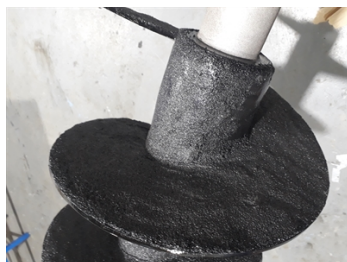
Initial condition

High abrasion was leading to unprotected screws only lasting 3-4 months in service. Previous Belzona applications on this type of screw was completed with Belzona 1812, which extended their life to over 2 years.

The screw conveyor was grit blasted to SA2 1/2 with a minimum surface profile of 3 mil (75 microns). The area to be coated was then cleaned and degreased using Belzona 9111. Belzona 1814 was applied to the entire area of the conveyor to provide long-term protection against heavy abrasion.

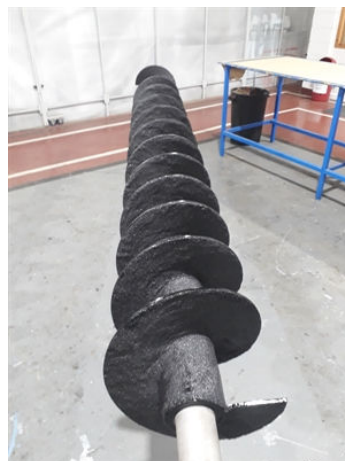
After Belzona 1814
