Belzona Saves Customers New Steel Chutes and Hoppers From Abrasion Attack

Application: *SHM-Solids Handling Machinery*

Substrate: *Carbon steel*

Products: *Belzona 1812 (Ceramic Carbide FP), Belzona 9111F*

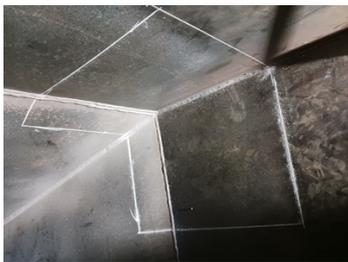
Area laid out for the application of Belzona 1812

The new chutes and hoppers had been blasted to an SSPC-SP10 near white finish c/w a 3mil depth profile, cleaned by using a vacuum, than degreased with Belzona 9111, and than Belzona 1812 was applied to the prepared surface at a thickness of 0.12"

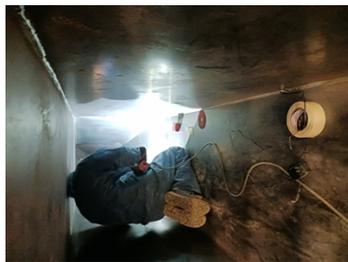
Shop Crew working on Preparation of chute and hopper

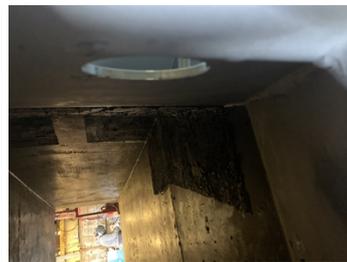
Belzona 1812 applied to the first area

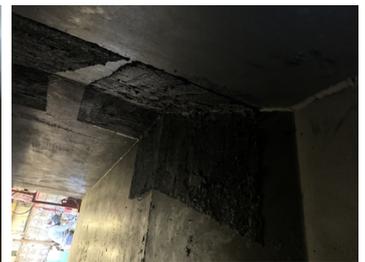
Belzona 1812 applied to both areas on the first chute and hopper
