Belzona Saves Customers New Steel Chutes and Hoppers From Abrasion Attack

ID: 9654

Application: *SHM-Solids Handling Machinery*

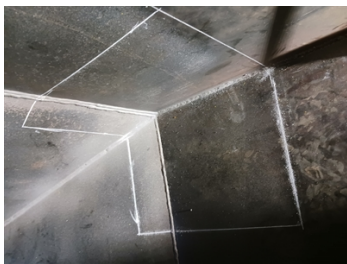
Area laid out for the application of Belzona 1812

The new chutes and hoppers had been blasted to an SSPC-SP10 near white finish c/w a 3mil depth profile, cleaned by using a vacuum, then degreased with Belzona 9111, and then Belzona 1812 was applied to the prepared surface at a thickness of 0.12"

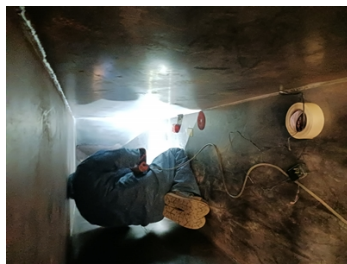
Shop Crew working on Preparation of chute and hopper

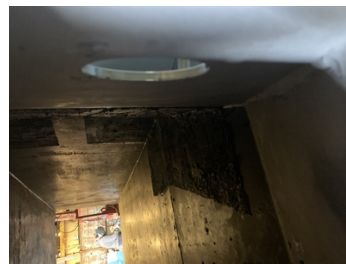
Belzona 1812 applied to the first area

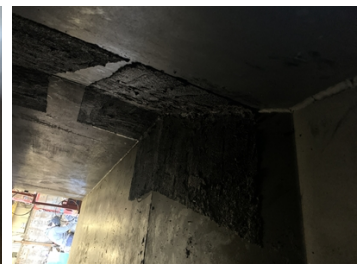
Belzona 1812 applied to both areas on the first chute and hopper
