Belzona Saves Customers New Steel Chutes and Hoppers From Abrasion Attack

Application: *SHM-Solids Handling Machinery*

Substrate: *Carbon steel*

Products: *Belzona 1812 (Ceramic Carbide FP),Belzona 9111F*

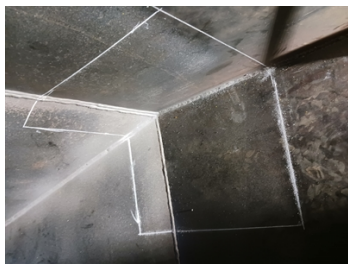
Area laid out for the application of Belzona 1812

The new chutes and hoppers had been blasted to an SSPC-SP10 near white finish c/w a 3mil depth profile, cleaned by using a vacuum, than degreased with Belzona 9111, and than Belzona 1812 was applied to the prepared surface at a thickness of 0.12"

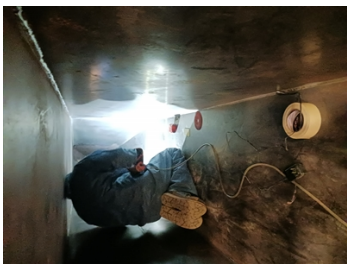
Shop Crew working on Preparation of chute and hopper

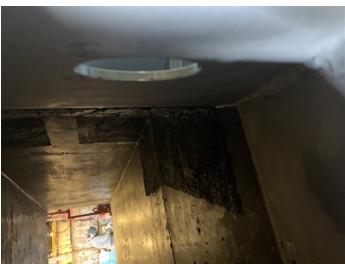
Belzona 1812 applied to the first area

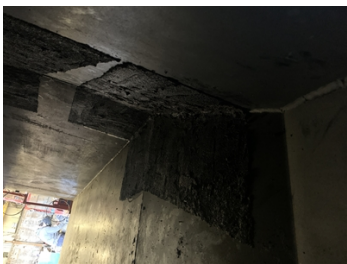
Belzona 1812 applied to both areas on the first chute and hopper
