# Belzona coating for mill scale wastewater channel in steel industry

ID: 9656

Industry: Steel & Metal Processing  
Application: SHM-Solids Handling Machinery

Customer Location: Bruck an der Mur  
Application Date: January 2022

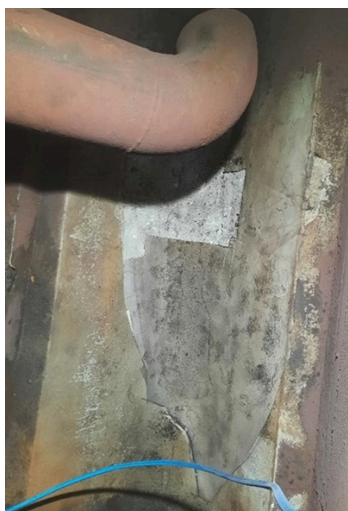
The competitor's repair was failing mainly between the concrete and the primer, but some delamination also occurred between the middle and top layer.

Damaged substrate

First the failing competitor coating had to be removed.

To prepare the substrate for the Belzona solution, the concrete substrate was grit blasted.

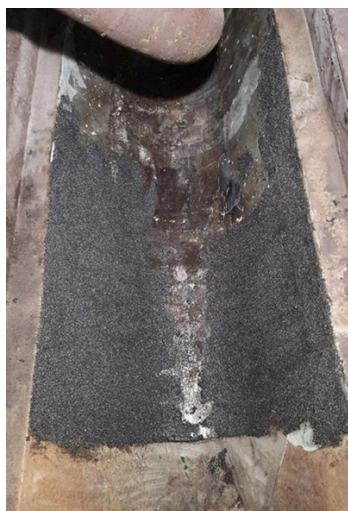
Application in progress

When applying the coating, first a smaller amount of Belzona 1814 resins was mixed without the aggregate to prime the concrete.

This improved the adhesion of the Belzona 1814 mixture with the aggregate to the concrete.  
Belzona 1814 was applied approximately 3-4mm thick.

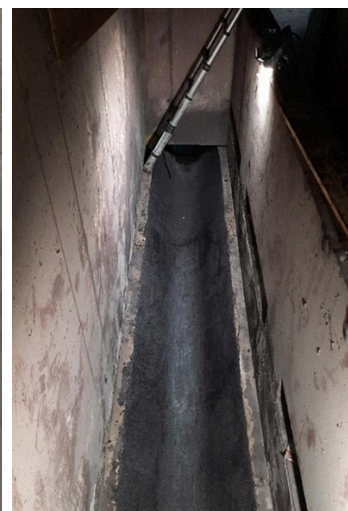
Finished application
