Test Separator Internal Coating

ID: 9657

Industry: Oil & Gas
Application: TCC-Tanks and Chemical Containment Areas
Substrate: Carbon steel
Products: Belzona 1511 (Super HT-Metal), Belzona 1593

Customer Location: Saudi Arabia
Application Date: October 2022

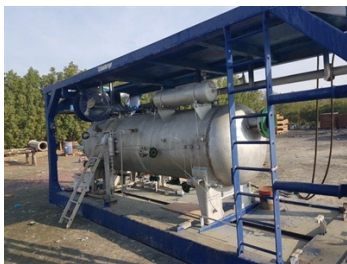
The test separator's internal surfaces suffered severe corrosion.

1. Rebuild the worn metal with Belzona 1511
2. Topcoat the internal substrate with Belzona 1593 to fully protect the surface from further attacks.

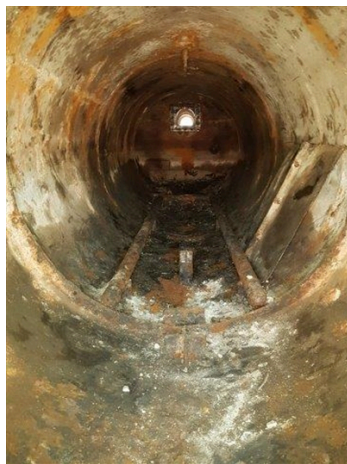
Internal surfaces were heavily corroded due to aggressive media.

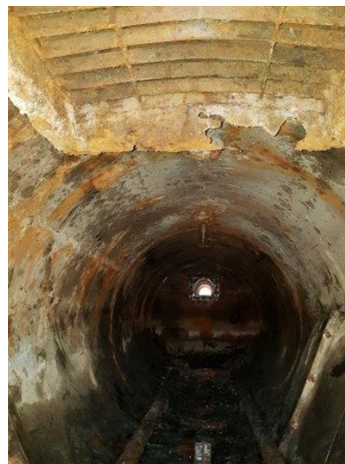
Evidence of severe corrosion damage on test separator internal surfaces

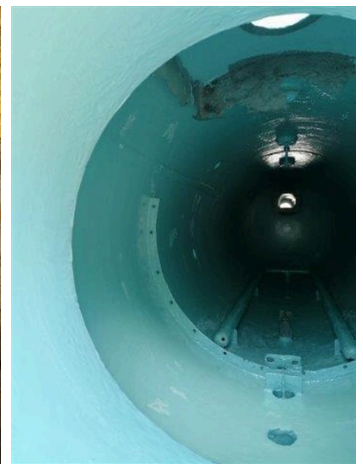
Complete application of Belzona solution on test separator internal surfaces
