# BELZONA DRAIN COVERS

ID: 966

Industry: General Industry  
Application: FPA-Floor Problem Areas  
Substrate: Stainless Steel  
Products: Belzona® 4111 (Magma Quartz)

Customer Location: Bakery, West Midlands, UK  
Application Date: May 2008

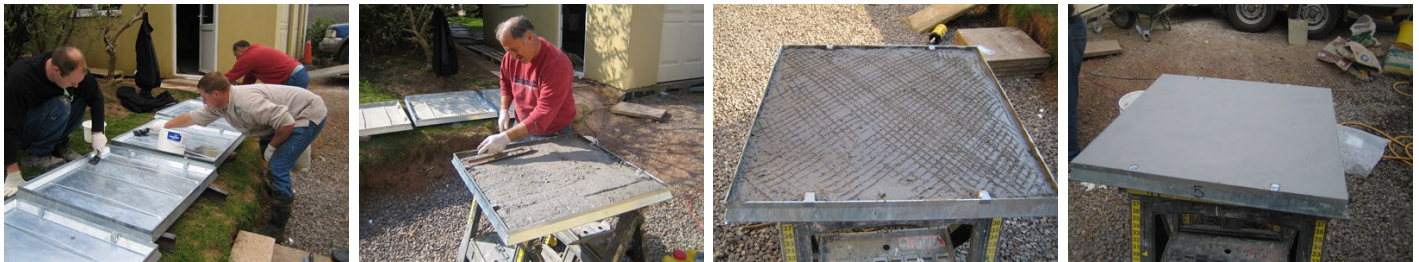
Existing covers and surrounds badly deteriorated due to corrosion and chemical attack. rapid solution required due to continuous production schedule on site. Conventional steel/concrete covers do not have adequate resistance.

\* Fabricated drain covers in Steel being conditioned , \* Bulk out Belzona® 4111 being applied , \* Bulk out Belzona® 4111 finished ready to be topped off with Belzona® 4111 , \* Finished cover ready for transport and installation on site ,

Application was carried out in accordance with a modified Belzona Know-How System Leaflet FPA-1. New drain covers were manufactured off-site from Stainless Steel and infilled with Belzona® 4111. On site bedded into Belzona® 4111 and damaged surrounds rebuilt.
