Cooling Water Head Brought Back To Life With Belzona 1391T

ID: 9661

Industry: Oil & Gas
Application: HEX-Heat Exchangers
Substrate: Carbon steel
Products: Belzona 1111 (Super Metal), Belzona 1391T

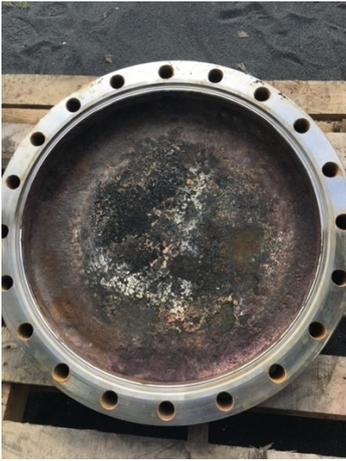
Customer pulled several HEX for routine inspections and discovered bad pitting on one the Cooling Water Heads. They were in a small Pit-Stop and had 3 days to get this repaired and back in service.

Cooling Water Head Before

We blasted and filled pitting with 1111, coated with 2 coats of 1391T.

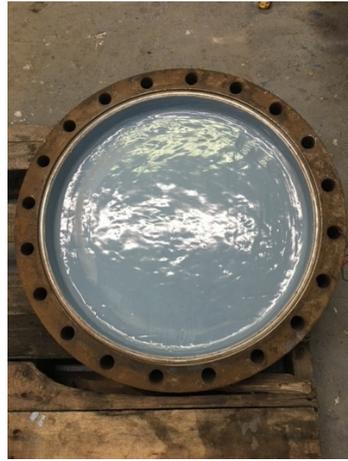
Cooling Water Head After
