Pipe bridge support repairs

ID: 9663

Industry: Chemical & Petrochemical

Application: FPA-Floor Problem Areas

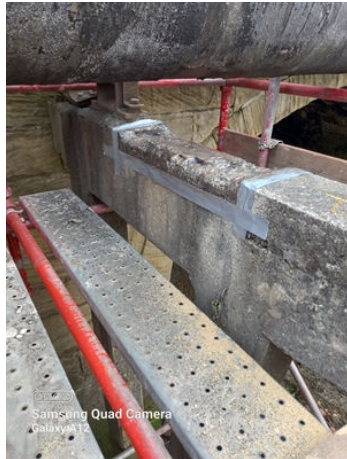
Several pipe supports had corroded and no longer provided support for the pipeline running across this bridge section.

Corroded pipe support

The areas were marked out, prepared, conditioned with Belzona 4911 & then repaired with Belzona 4111. For a larger area a shutter was built around & Belzona 4111 poured into to fill up to the desired level.

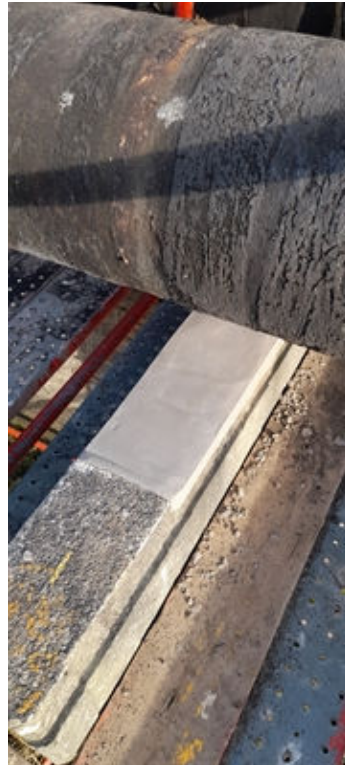
Area prepared

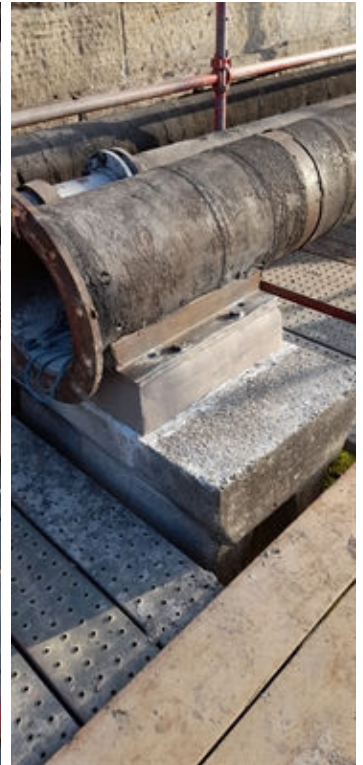
Completed section

Larger support repaired using shutter & pour method
