Belzona 3131 long term roof protection

ID: 9664

Industry: Water / Wastewater
 Application: RPA-Roof Problem Areas
 Substrate: Other
 Products: Belzona 3131 (WG Membrane)

Customer Location: Scotland
 Application Date: July 2020

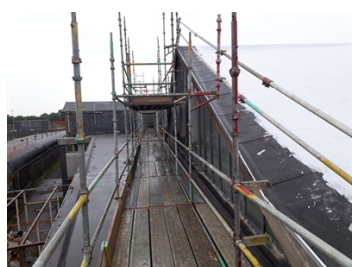
Belzona 3131 application

The roofs were first power washed, treated with fungicide. Two coats of Belzona 3131 WG Membrane were then applied.

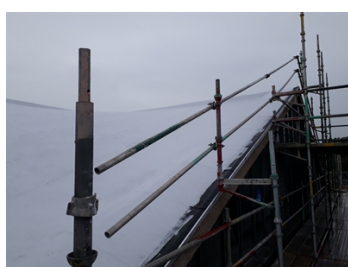
Application underway

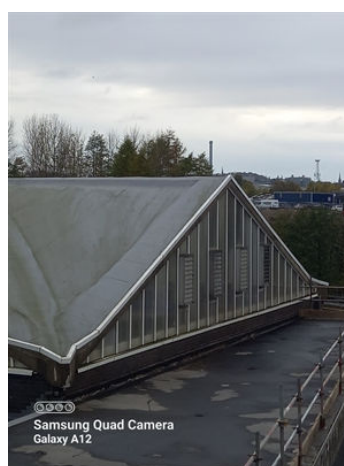
Roof section after 4 years service

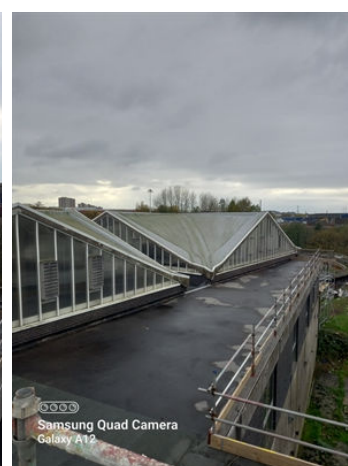
Still in excellent condition
