PROCESS WATER TANK LINING RESTORATION

ID: 9667

Application: TCC-Tanks and Chemical Containment Areas

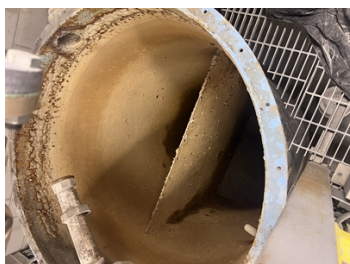
Process water lining was experiencing corrosion due to erosion.

Tank before refurbishment.

Lining of process tank was experiencing deterioration due to erosion corrosion and required to be cleaned and protected from further damage.

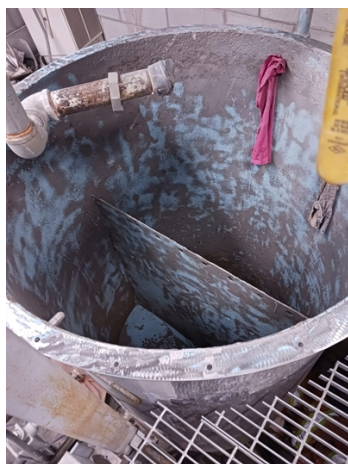
Lining after abrasive blasting.

The lining was cleaned to the required level of cleanliness by abrasive blasting and the external by power tool cleaning. The tank was further cleaned and degreased by using Belzona 9111. Two coats application of Belzona 1341 was applied as lining while two coats of Belzona 6111 primer and two coats of Belzona 5111 was applied as coating.

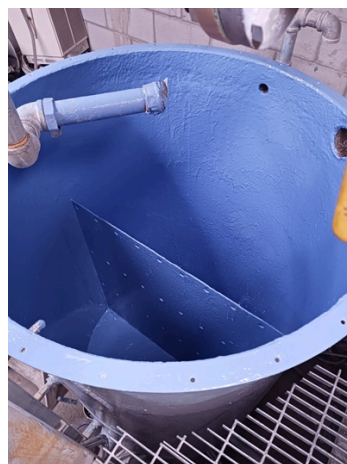
Lining after two coats of Belzona 1341.

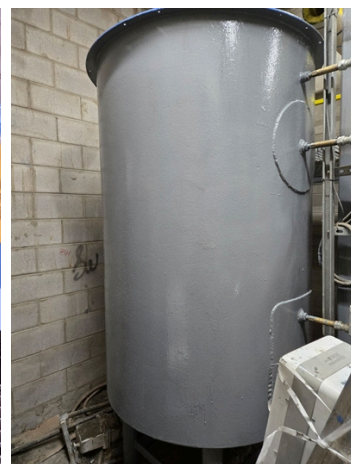
After application of external coating.
