PROCESS WATER TANK LINING RESTORATION

ID: 9667

Application: *TCC-Tanks and Chemical Containment Areas*

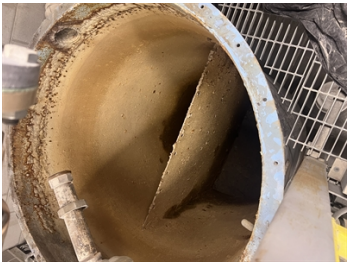
Process water lining was experiencing corrosion due to erosion.

Tank before refurbishment.

Lining of process tank was experiencing deterioration due to erosion corrosion and required to be cleaned and protected from further damage.

The lining was cleaned to the required level of cleanliness by abrasive blasting and the external by power tool cleaning. The tank was further cleaned and degreased by using Belzona 9111. Two coats application of Belzona 1341 was applied as lining while two coats of Belzona 6111 primer and two coats of Belzona 5111 was applied as coating.

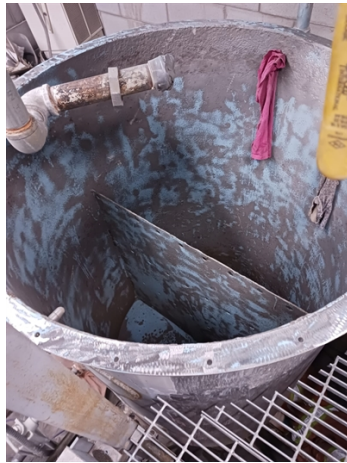
Lining after abrasive blasting.

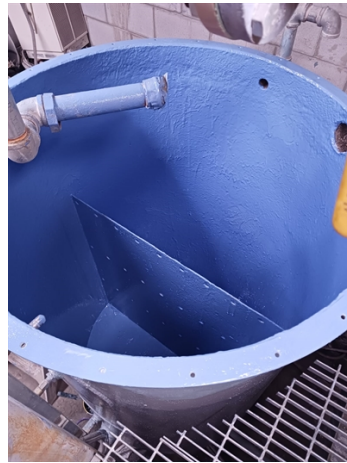
Lining after two coats of Belzona 1341.

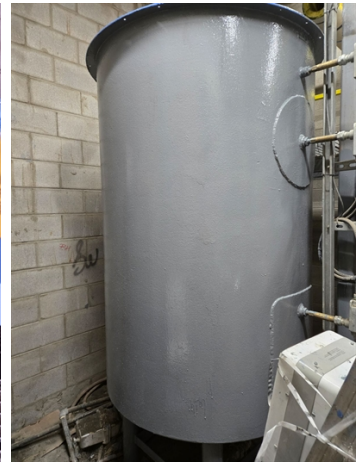
After application of external coating.
