Belzona Prevents Plant Shutdown By Curtailing High Pressure Pipe Leak

ID: 9671

Application: VPF-Valves, Pipes and Fittings

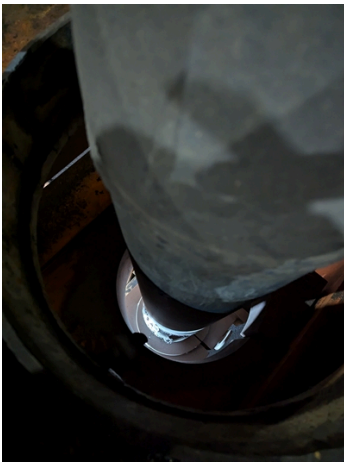
Pipe after surface preparation.

The affected area was cleaned to the required level of cleanliness as stated in the products IFU and procedure for repairing leaks in pipes (VPF-11) by abrasive blasting. Belzona 1212 was used to cover both the weld seams and the metal plate before wrapping with Belzona super wrap II kits.

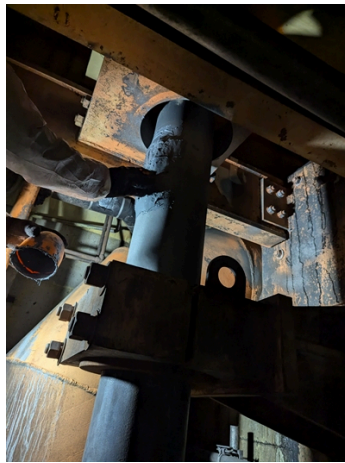
Pipe and metal plate covered with Belzona 1212.

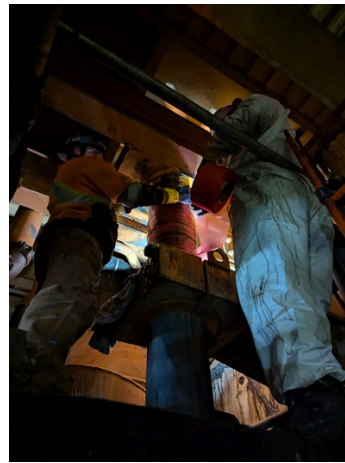
Super Wrap II was installed.
