Belzona Prevents Wear on a Seafood Processor

ID: 9688

Industry: Marine
Application: SOS-Ships and Offshore Structures

Substrate: Stainless-steel
Products: Belzona 1311 (Ceramic R-Metal)

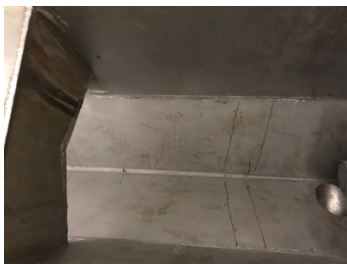
This seafood waste chopper was wearing down from many years of use resulting on the shaft getting bowed and causing the large heavy chopper head to jam.

Original condition.

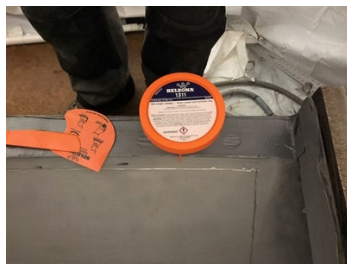
Ready to apply the Belzona 1311.

The surface was grit blasted and washed with solvent, and then the Belzona 1311 was carefully applied by hand in a thin smooth layer.

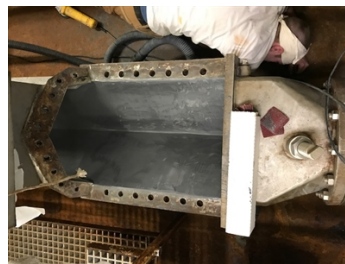
Application complete.
