# Repairing a leaky crack in a hot oil system

ID: 9691

**Application:** VPF-Valves, Pipes and Fittings

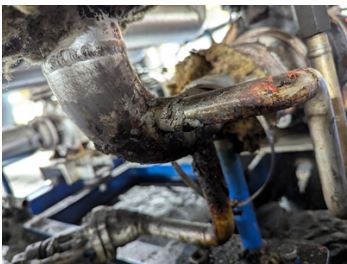
Substrate after surface preparation.

The oil was still seeping at the moment of application, so we needed to stem the leak first. Thus, after doing surface preparation we stemmed the leak with Belzona 1221, thanks to its fast-curing properties. Then we proceed to do a few wraps of Belzona 1511 with Belzona 9341.

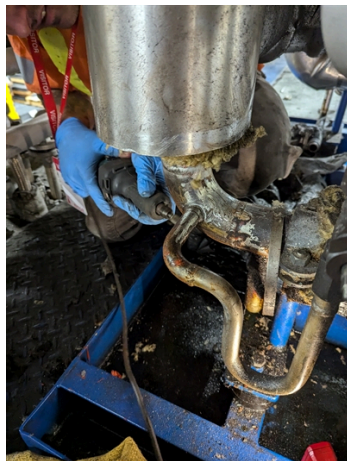
Sealing with Belzona 1221.

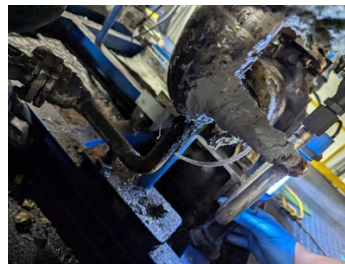
Rebuilding with Belzona 1511.

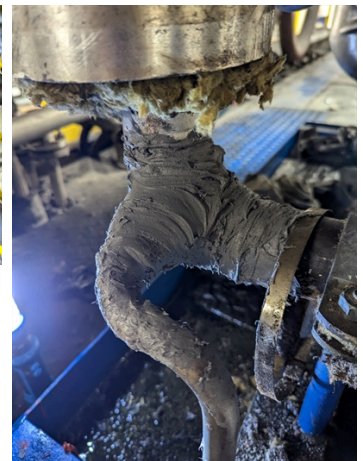
Entire area covered with Belzona 1511.
