Belzona Saves Salt Hopper in a Municipal facility.

Industry: Local Authorities & Municipalities
 Application: TCC-Tanks and Chemical Containment Areas
 Substrate: Carbon steel
 Products: Belzona 6111 (Liquid Anode)

Customer Location: Kitchener, Ontario
 Application Date: October 2013

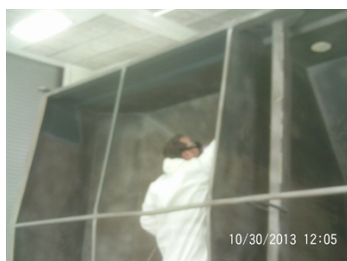
Hopper was experiencing extreme rate of corrosion due to salt contamination and abrasion.

Hopper before application.

Hopper was grit blasted to the required level of cleanliness as recommended in the products IFU. After require QA/QC checks, Belzona was applied and post application testing was done for require parameters.

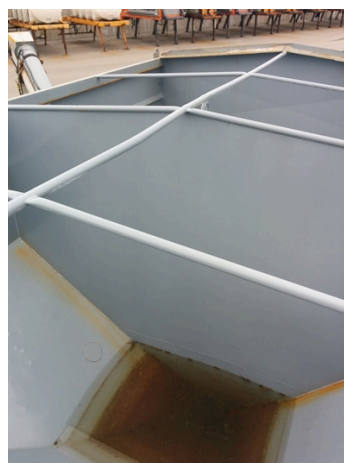
Hopper during Belzona application.

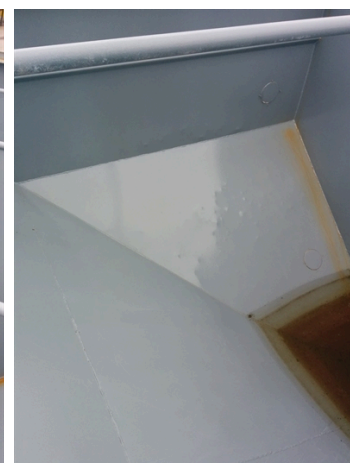
Hopper after a year in service.

Belzona was able to protect the hopper better than previously used coatings as after a year, hopper still appears in good shape.
