# Concrete Stairs saved from further dilapidation.

Industry: Local Authorities & Municipalities  
Application: FPA-Floor Problem Areas  
Substrate: Concrete  
Products: Belzona 4111 (Magma-Quartz)

Customer Location: Ontario  
Application Date: September 2014

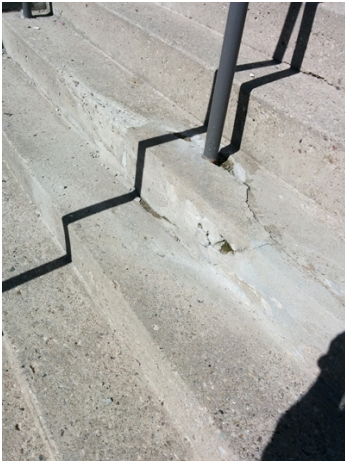
Stairs was experiencing cracks along the railing pillar and was on the verge of falling apart.

Cracks on stairs before repair.

Concrete stairs was on the verge of falling apart due to stress from the railings and customer wanted a fast repair that would enable the area opened to the public in the fastest way.

The weak parts of the concrete stairs was removed and vacuumed. The areas were subsequently rebuilt with Belzona 4111.

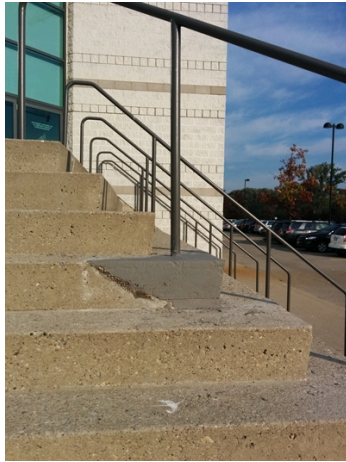
Further cracks .

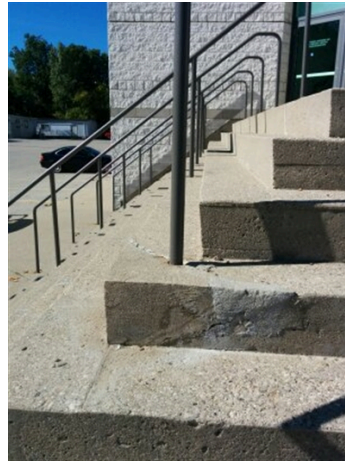
After surface preparation.

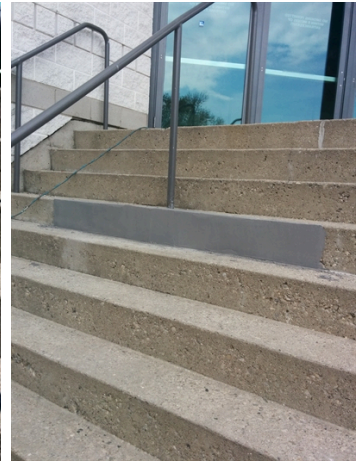
Stairs after repair.

Belzona repair was carried out and the area opened to for public use in matter of days.
