An Auger in a concrete precast company gets the Belzona treatment.

ID: 9702

Application: SHM-Solids Handling Machinery

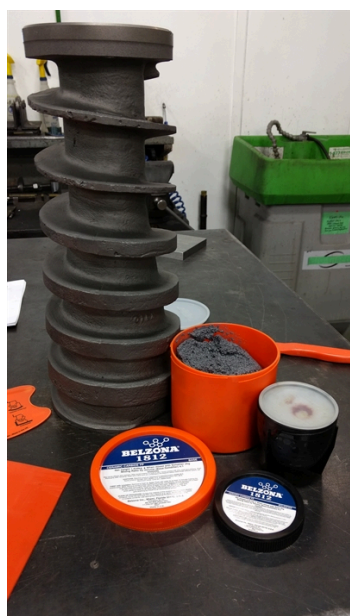
Auger after abrasive blasting.

The part was grit blasted to the required level of cleanliness as stipulated on the product's IFU. The vanes were then covered with Belzona 1812 for optimum abrasion resistance.

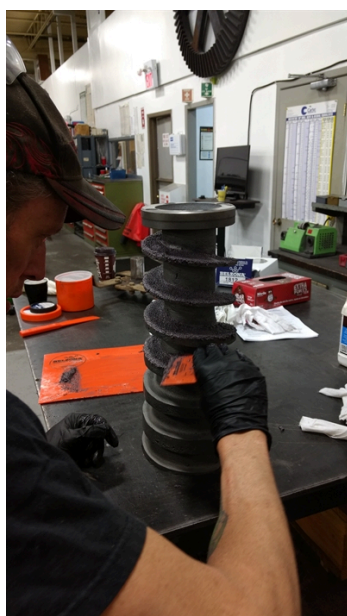
Auger during application of Belzona 1812.

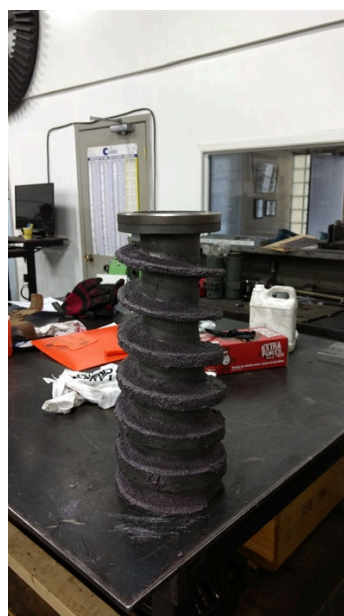
Application completed with Belzona 1812.

The customer put the auger in service and inspected it after few weeks to ascertain the level of protection by Belzona. They were pleased to see that the equipment itself is isolated from the abrasive nature of the concrete components.
