Heavily corroded air handling unit needed some Belzona

ID: 9703

Application: TCC-Tanks and Chemical Containment Areas

Products: Belzona 1161 (Super UW-Metal), Belzona 1981 (SuperWrap II)

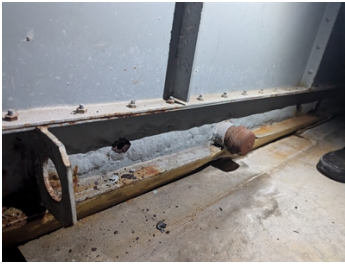
Unit before cleaning.

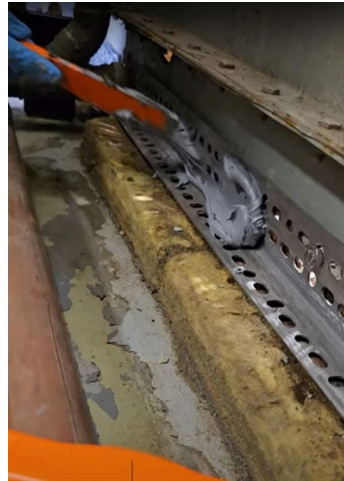
During application of Belzona 1161.

All structurally unsound steel areas were removed, and the entire surface was mechanically roughened to ensure proper adhesion. The removal of rusted steel left several large holes, which were addressed by installing metal reinforcing plates. Belzona 1161 was then applied for bonding and sealing, followed by the use of Belzona 9381 in combination with 9371 fiberglass mesh to provide additional reinforcement and durability.

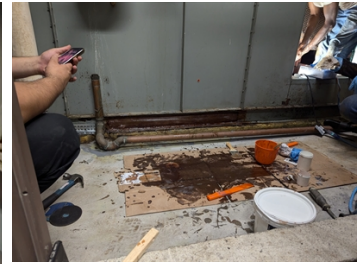
Application completed with Belzona 1981 with reinforcement mesh Belzona 9371.
