Heavily corroded air handling refurbished with Belzona 5831

ID: 9704

Industry: Heating, Ventilation & Air Conditioning
Application: TCC-Tanks and Chemical Containment Areas
Substrate: Carbon steel
Products: Belzona 5831 (ST-Barrier)

Customer Location: Ontario
Application Date: August 2024

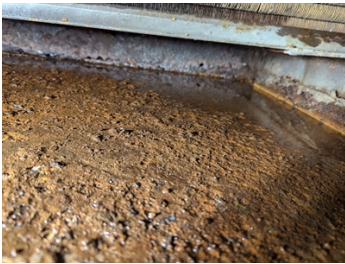
Two air handling units were heavily corroded and leaking in several areas. The whole basin needed to be coated and properly sealed.

One of the basins before cleaning.

The customer left these units untreated and unprotected for many years, resulting in significant deterioration. The rust needed to be removed, and coating was required to protect and extend the life of these units.

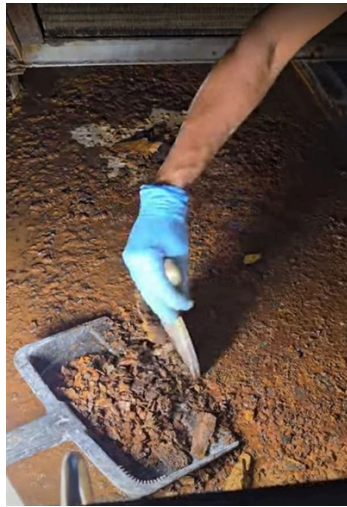
Basin during surface preparation.

All the rusty areas were scrapped and removed with a putty knife followed by power tool cleaning. Then two coats of Belzona 5831 were applied. The system was allowed to cure for 2 days before being put back in service.

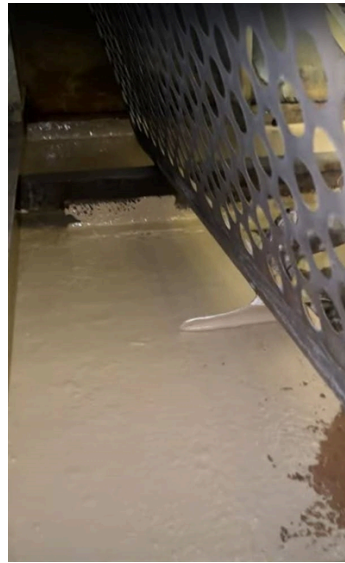
During application of Belzona 5831

The surface-tolerant properties of Belzona 5831 were essential for this application. There was significant moisture and condensation on the surface, making it impossible to fully dry, and the substrate was so deteriorated that achieving ideal surface preparation was challenging.

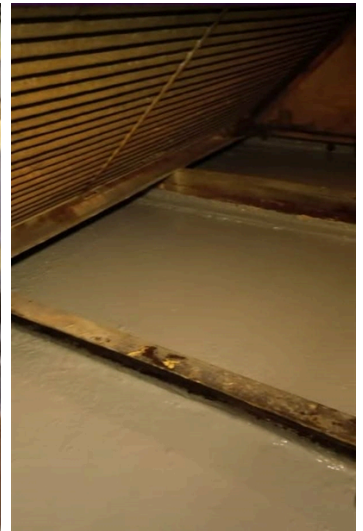
Both units after coating application.
