Hospital Drain

ID: 9706

| Application: | FPA-Floor Problem Areas | Application Date: | August 2024 |

Problem
Drain was leaking in patients room.

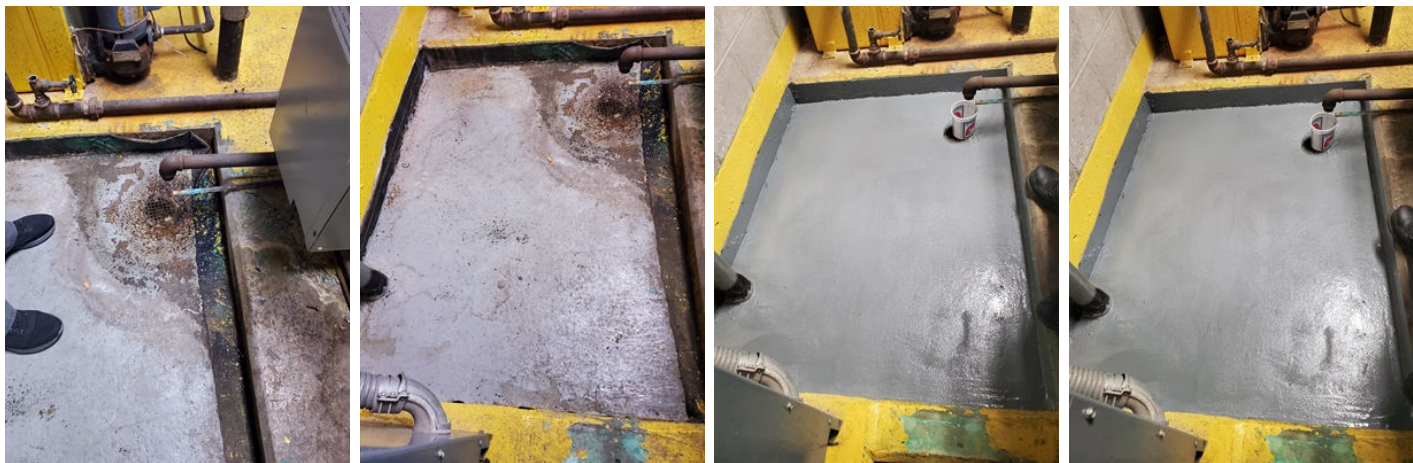
Drain condition before repair with Belzona

Final application of Belzona solution

Customer was planning on replacing the concrete and drain before I gave them the option to repair it.

Concrete was prepared with hand tools and cleaned before doing the repair.

Belzona was cheaper and less time consuming than to replace the old concrete and drain
