# BASF Plate Bond on Hopper

Industry: *Chemical & Petrochemical*  
Application: *TCC-Tanks and Chemical Containment Areas*  
Substrate: *Carbon steel*  
Products: *Belzona 1111 (Super Metal)*

Customer Location: *Sparta TN*  
Application Date: *July 2024*

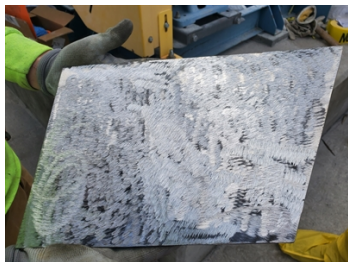
Surface preparation in the plate

Plate was cut to size and roughened, and hopper was also prepared using hand tools. Belzona 1111 was applied to both surfaces.

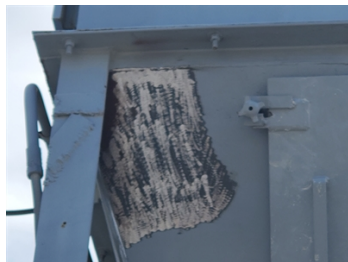
Surface preparation in the equipment

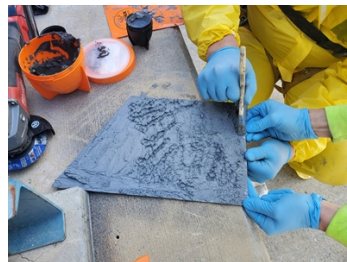
Application of Belzona 1111 on the plate

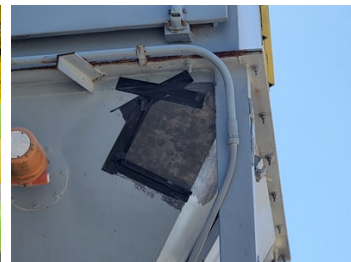
Plate bonding completed
