BASF Plate Bond on Hopper

ID: 9707

Industry: *Chemical & Petrochemical*
Application: *TCC-Tanks and Chemical Containment Areas*
Substrate: *Carbon steel*
Products: *Belzona 1111 (Super Metal)*

Customer Location: *Sparta TN*
Application Date: *July 2024*

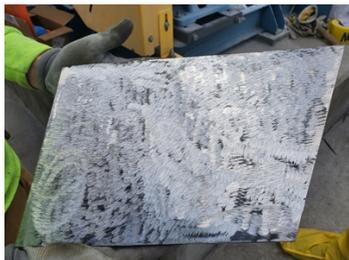
Surface preparation in the plate

Plate was cut to size and roughened, and hopper was also prepared using hand tools. Belzona 1111 was applied to both surfaces.

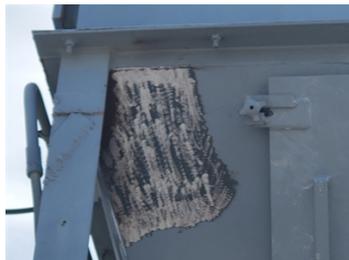
Surface preparation in the equipment

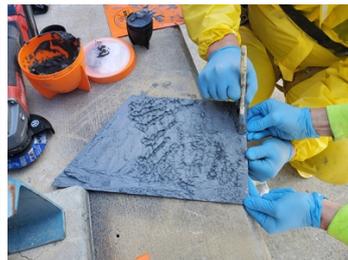
Application of Belzona 1111 on the plate

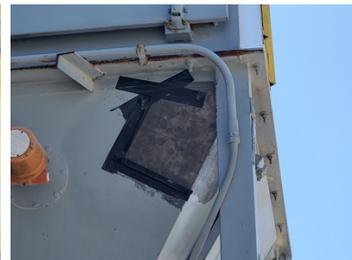
Plate bonding completed
