Bonnell Sump

Customer Location: *Gordonsville TN*

Application: *FPA-Floor Problem Areas*

Products: *Belzona 4111 (Magma-Quartz), Belzona 4341 (Magma CR4)*

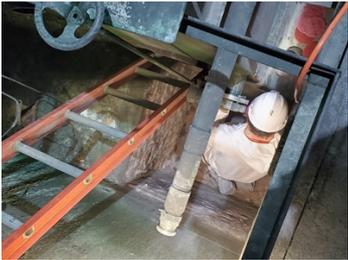
Customer had a leaking sump and damaged concrete.

Application area.

Contractor has to prepare the concrete and follow guidelines for air quality and confine space. Belzona 4111 was used to rebuild the concrete and Belzona 4341 to provide chemical resistance protection.

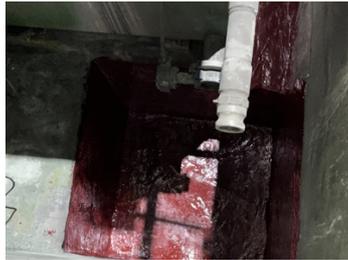
Application in progress.
