# Bonnell Sump

Application: FPA-Floor Problem Areas

Products: Belzona 4111 (Magma-Quartz), Belzona 4341 (Magma CR4)

Customer Location: Gordonsville TN

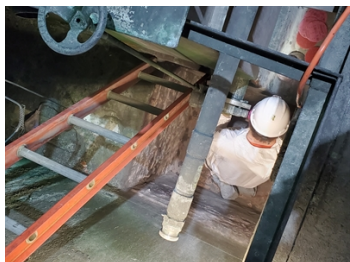
Customer had a leaking sump and damaged concrete.

Application area.

Contractor has to prepare the concrete and follow guidelines for air quality and confine space. Belzona 4111 was used to rebuild the concrete and Belzona 4341 to provide chemical resistance protection.

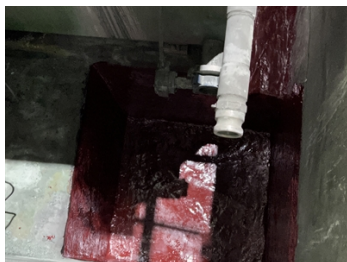
Application in progress.
