# Attritor Repair with Belzona

ID: 9715

Industry:	Chemical & Petrochemical	Customer Location:	Dalton GA
Application:	SHM-Solids Handling Machinery	Application Date:	June 2024
Substrate:	Masonry		
Products:	Belzona 1511 (Super HT-Metal),Belzona 1813,Belzona 9811

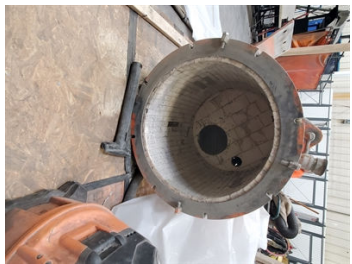
Overview of repair area.

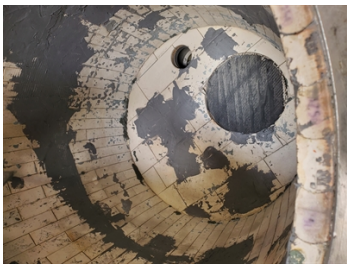
Overview of repair area.
