Pump Shaft Repair

ID: 9718

Application: FBC-Fans, Blowers and Compressors

Products: Belzona 1131 (Bearing Metal)

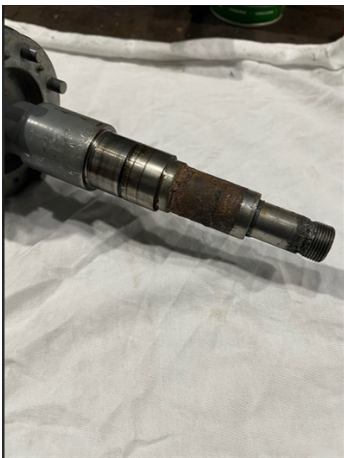
One of the pump shafts in the machinery shop showed damage near the sealing area. Following our initial consultation, they ask for guidance on how to fix it without having to replace it. Because of its self-lubricating qualities, Belzona Bearing Metal 1131 was recommended.

Shaft Initial Condition

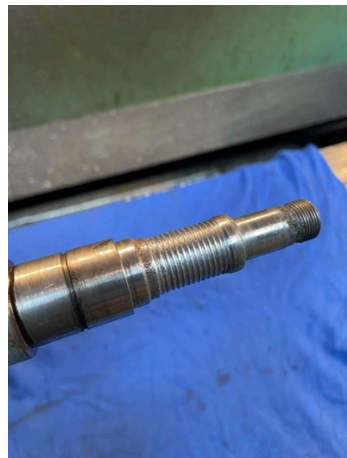
Surface prepared

Workshop execute the FBC-12 procedure from the System Leaflets. A lathe was used for the surface preparation and the undercut of the excess material.

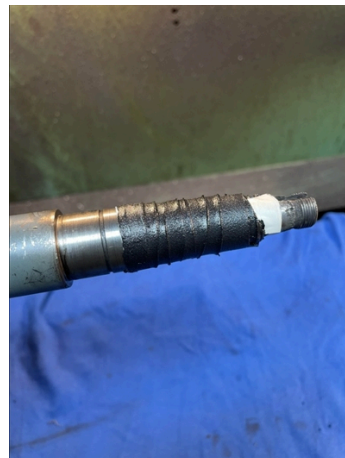
Bearing Metal Application

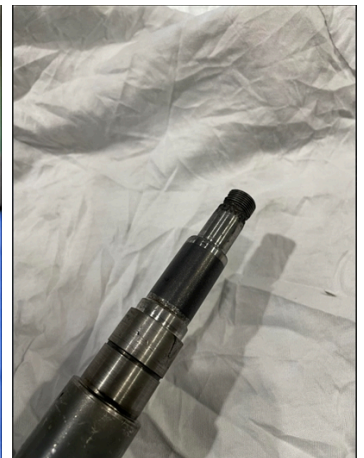
Complete repair

Belzona provided the client with a quick and reasonably priced repair. Both the end user and the workshop were quite happy with the result.
