BELZONA IN-SITU TANK REPAIR

ID: 972

Paint booth process water tank

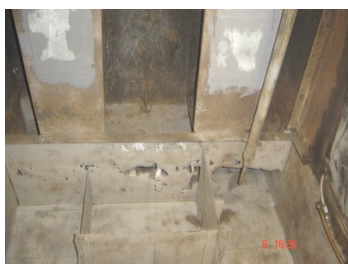
Corrosion and leaking tank. To replace tank with new was costly and would result in production downtime of 7-10 working days.

* Tank cleaned and shot blasted , * Vacuum column prior to plate being bonded , * Remedial work/plates bonded in place , * Tank complete after 2 coats of Belzona® 5811 ,

Application was carried out in accordance with Belzona Know-How System Leaflets TCC-1 & -3. doubler plates were bonded over perforated steelwork before applying corrosion resistant coating.
