Cooling Tower Pipe Leak Repair

ID: 9721

Industry: Oil & Gas
Application: VPF-Valves, Pipes and Fittings
Substrate: Carbon steel
Products: Belzona 1212, Belzona 1982 (SuperWrap II), Belzona SuperWrap, Accessories, Belzona 9111 (Cleaner Degreaser), Belzona 9611 (ES-Metal)

Customer Location: Southwestern Ontario
Application Date: November 2024

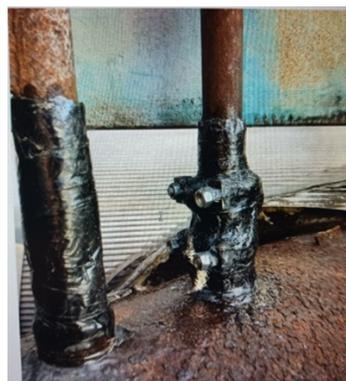
1 inch steel pipe had corrosion and was leaking at the pipe seam and socket weld joint

X-Ray showing the socket joints and pipes Picture showing pipe leaking.

Heavy rust was removed by a tapping the pipe with a hammer and than the preparation was completed using pneumatic air hand tooling, needle gun and grinder.

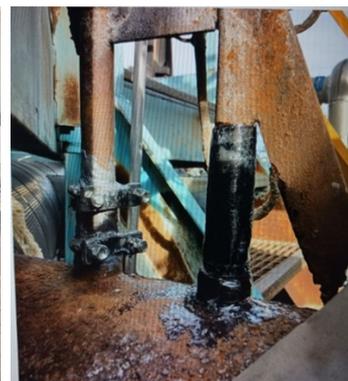
Picture show's water leak has been stopped and application completed.
