# Ferry Capstan winch rebuilt with Belzona 1111

ID: 9724

Industry: Marine  
Application: SOS-Ships and Offshore Structures

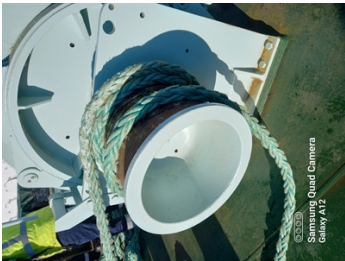
A capstan used for hauling mooring ropes was over coiling due to an insufficient chamfer. Build up using weld overlay would be prohibitively expensive & time consuming within the timeframe available.

Ropes overcoiling

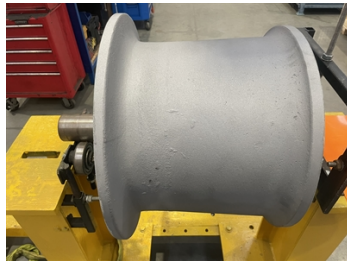
Grit blast surface preparation

The capstans were grit blasted to SA2.5 & minimum 75 microns. Belzona 1111 was then used to build a larger chamfer.

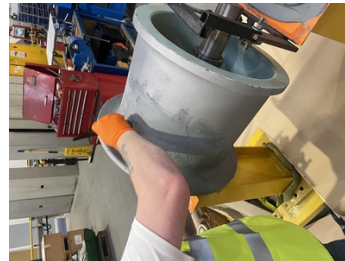
Wetting out the surface

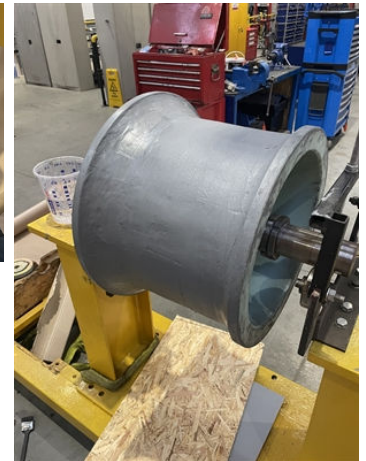
Build up of Belzona 1111

Using the Belzona solution meant the capstans could be rebuilt without possible heat distortion of the substrate
