Belzona Coating Nets an Increase of 700 GPM on Water Municipality Pump

ID: 9729

Industry: Water / Wastewater
Application: CEP-Centrifugal Pumps
Substrate: Cast Iron
Products: Belzona 1311 (Ceramic R-Metal), Belzona 1341N (Supermetalglide), Belzona 9411 (Release Agent)

Customer Location: Columbus, OH
Application Date: September 2019

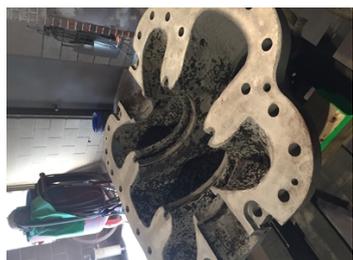
Serious corrosion impacted efficiency. The wear rings were rebuilt also.

This pump was grit blasted to SSPC SP 10 near white finish. The cutwater was rebuilt by tack welding expanded metal and then using Belzona 1311 (Ceramic R-Metal) to reform it. The wear ring seats were rebuilt using Belzona 1311 (Ceramic R-Metal) and using new wear rings that were coated with Belzona 9411 (Release Agent) as formers. After these repairs were properly cured, two 10-mil coats of Belzona 1341N (Supermetalglide) was applied.

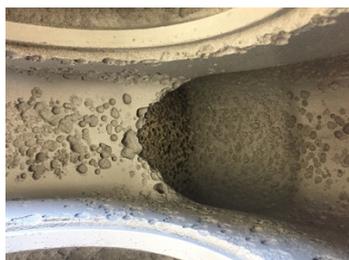
Cutwater was severely eroded.

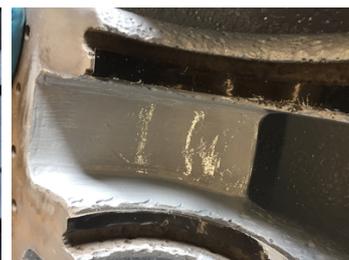
This picture shows the cutwater and wear rings rebuilt and coated.
