Fleet Facility Floors are Cleaner and Safer Thanks to Belzona 5231

Industry: Local Authorities & Municipalities
Application: FPA-Floor Problem Areas
Substrate: Concrete
Products: Belzona 4521 (Magma-Flex Fluid), Belzona 4911 (Magma TX Conditioner), Belzona 5231 (SG Laminate)

Customer Location: Columbus, OH
Application Date: January 2025

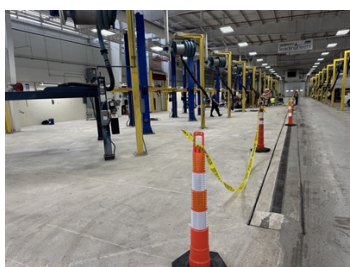
This building is being done in 4 sections. This area has been blast cleaned and is ready for Belzona 5231.

The contractor had to remove 2 layers of old floor coating by grit blasting and scraping. Belzona 4911 (TX-Conditioner) was "stippled" into the substrate. Then foam backer rod was inserted to the correct depth. Belzona 4521 was then applied per the IFU. Lastly, two 6-mil coats of Belzona 5231 (SG Laminate) with aggregate were applied by squeegee and roller over the entire section.

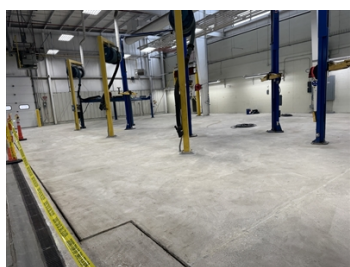
Expansion joints are being rebuilt with foam backer rod, Belzona 4911 and Belzona 4521.

The expansion joints are also being done with Belzona 4521.

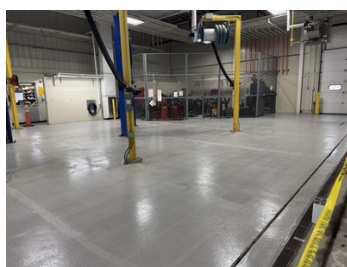
Finished section.

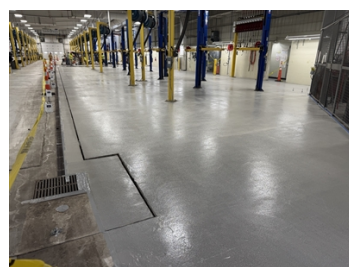
Finished section.
