Distressed Water Pump Rebuilt and Coated with Belzona 1341N

ID: 9731

Industry: Power
Application: CEP-Centrifugal Pumps
Substrate: Cast Iron
Products: Belzona 1311 (Ceramic R-Metal), Belzona 1321 (Ceramic S-Metal), Belzona 1341N (Supermetalgilde)

Customer Location: Chandler, IN

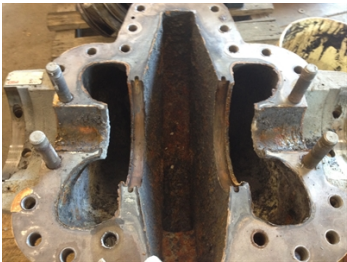
General damage to the pump casing, wear ring areas, and packing areas.

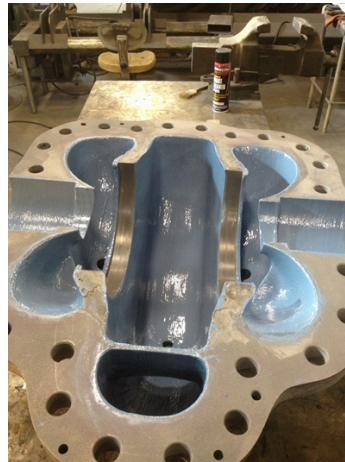
After the wear rings and packing areas were rebuilt with Belzona 1311 (Ceramic R-Metal) the first coat of Belzona 1321 (Ceramic S-Metal) was applied.

After a grit blast Belzona 1311 was used to rebuild the wear rings and packing areas. Then one coat of Belzona 1321 (Ceramic S-Metal) was applied by brush. This was followed by two coats of Belzona 1341N (Supermetalgilde), a hydrophobic coating for energy efficiency.

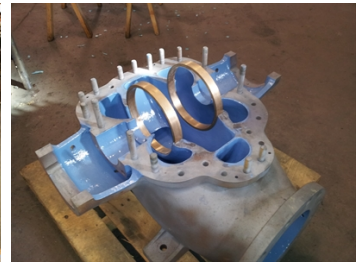
Two coats of Belzona 1341N (Supermetalgilde) were applied. Pump is ready to be reassembled.
