# Brine Heat Exchanger Cover Refurbishment

ID: 9732

**Customer Location:** Teesside  
**Application Date:** September 2024

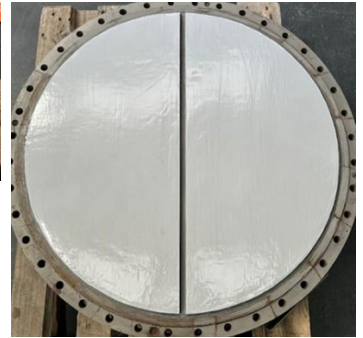
Belzona 1593 application first coat.

After removing the existing coating, soluble salts were removed from all surfaces prior to starting the Belzona application. Surfaces were then rebuilt using Belzona 1511, before applying the high temperature coating Belzona 1593.

All parts of the heat exchanger were then protected with a simple brush application of Belzona 1593 which is capable of withstanding immersion conditions of 160°C.
