# Brine Heat Exchanger Water Box Refurbishment

ID: 9734

**Industry:** Chemical & Petrochemical  
**Application:** HEX-Heat Exchangers  
**Substrate:** Carbon steel  
**Products:** Belzona 1511 (Super HT-Metal), Belzona 1593, Belzona 9111 (Cleaner Degreaser)

**Customer Location:** Teesside  
**Application Date:** September 2024

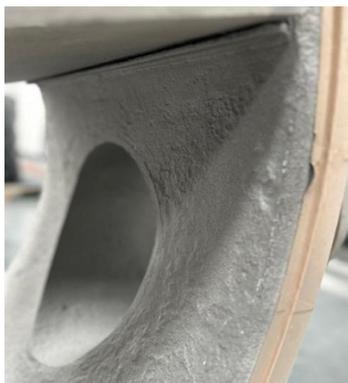
The water box had suffered pitting corrosion and needed resurfacing. In addition, the client required a lining to prevent further attack to the tube face, water box and cover.

Pitting damage of Water Box after grit blasting.

After removing the existing coating, soluble salts were removed from all surfaces prior to starting the Belzona application. Surfaces were then rebuilt using Belzona 1511, before applying the high temperature coating Belzona 1593. The refurbishment also included the water box cover and the tube face on this heat exchanger. Applications were carried out in accordance with Belzona Know-How System Leaflet HEX-1, HEX-2 and HEX-3.

Belzona 1511 is a high temperature resistant paste grade and was used to rebuild metal loss and resurface the pitted areas. All parts of the heat exchanger were then protected with a simple brush application of Belzona 1593 which is capable of withstanding immersion conditions of 160°C. The client was delighted with the refurbishment, which had been completed for a fraction of the cost of a replacement.

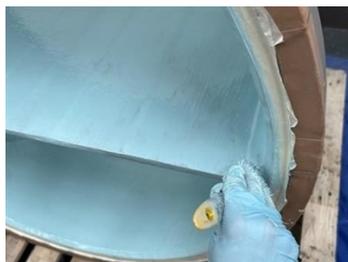
Belzona 1593 application first coat.

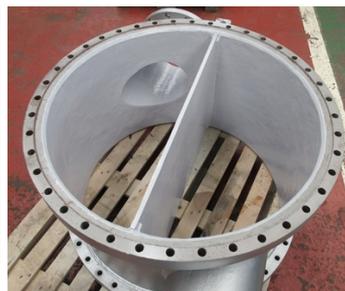
Belzona 1593 application completed.
