# Brine Heat Exchanger Water Box Refurbishment

ID: 9734

Industry: Chemical & Petrochemical

Application: HEX-Heat Exchangers

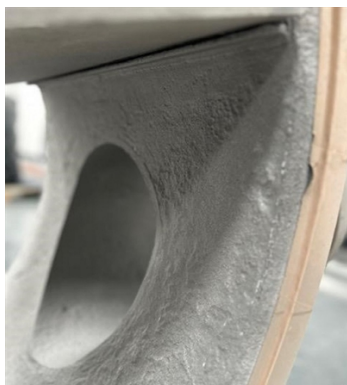
The water box had suffered pitting corrosion and needed resurfacing. In addition, the client required a lining to prevent further attack to the tube face, water box and cover.

Pitting damage of Water Box after grit blasting.

After removing the existing coating, soluble salts were removed from all surfaces prior to starting the Belzona application. Surfaces were then rebuilt using Belzona 1511, before applying the high temperature coating Belzona 1593.

Belzona 1511 is a high temperature resistant paste grade and was used to rebuild metal loss and resurface the pitted areas.

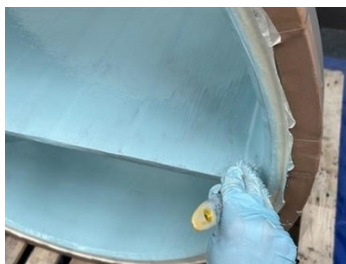
Belzona 1593 application first coat.

All parts of the heat exchanger were then protected with a simple brush application of Belzona 1593 which is capable of withstanding immersion conditions of 160°C.
