Belzona repairs scored shaft on a valve

ID: 9735

Industry: Power
Application: MPT-Mechanical Power Transmission

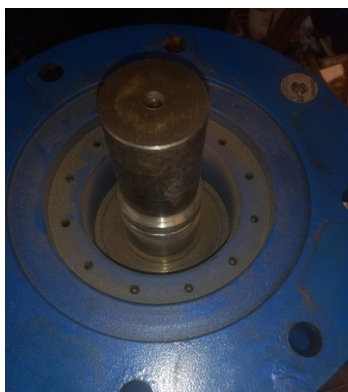
Surface preparation

The score was first ground out using a pencil grinder. It was also heated to remove any oil within the substrate. Belzona 1212 was then applied & overbuilt by ~2mm. The product was then dressed down smooth with the shaft surface.

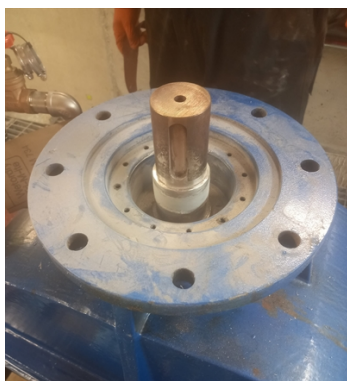
Belzona 1212 application

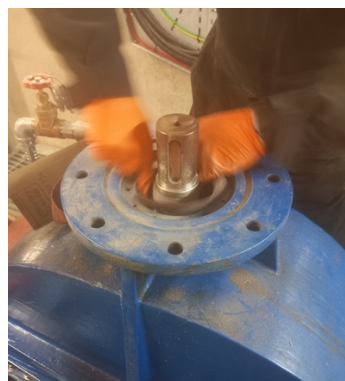
Dressing down repair
