Belzona SuperWrap II ABS approved system Repairs Leaks USNS PFC Dewayne T. Williams Vessel

ID: 9737

Industry: Marine Customer Location: Guam
Application: VPF-Valves, Pipes and Fittings Application Date: September 2024
Substrate: Carbon steel
Products: Belzona 1161 (Super UW-Metal), Belzona 1982 (SuperWrap II)

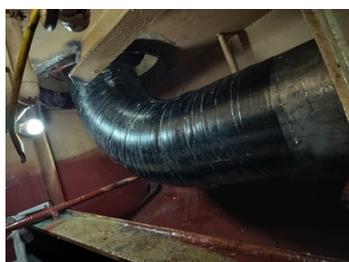
Pipe Section One - SuperWrap
II Completed

The application method was in accordance with SuperWrap II best practices in application of the system. The surface was prepped with an MBX to and SSPC SP-11 Bare Metal Machine finish. Belzona 1161 was used in the welds and joint areas to smooth and even the surface for wrapping. Two wraps were done as per the specification.

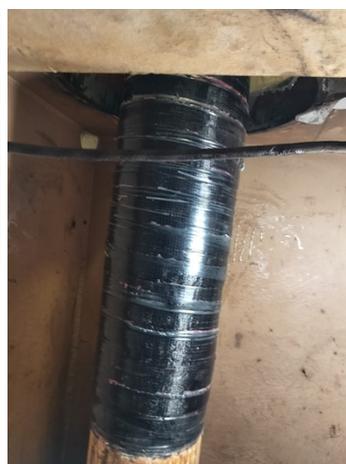
Pipe Section Two SuperWrap II
Completed

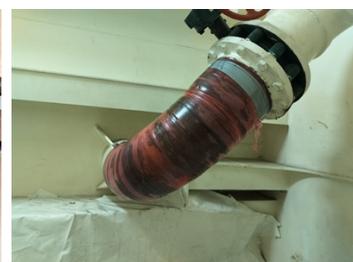
Pipe Section Three SuperWrap
II Completed
